**Flood Control Project Maintenance
Levee Inspections**

Maintenance Issue Types Only, Levee Inspection Report By Mile - Spring 2017

Reclamation District No. 2064 River Junction

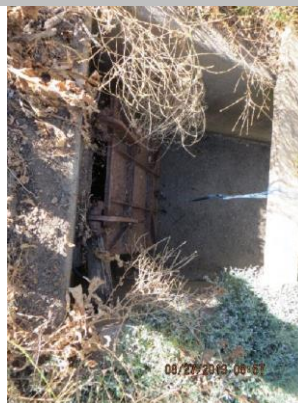
Photo 2 of 3 : UCIP_SP_2017_43603_31257.jpg

LM Start	0.06	Rating **	A/W	Issue No.	28 (cont)
LM End	0.06	Issue Type +	Ma	Location *	LS
Category	Supplemental			GPS Latitude/Longitude	
				Start	End
Item	DWR UCIP LMA Responsibility			37.709804 °	37.709804 °
				-121.267559 °	-121.267559 °
DWR ID					
Comment Code					
Inspector Comment					
FS_ID:43603 DS_ID:20511 EP_NO: N/A Repair Type: No Action Needed Crossing Status: Found UCIP Comments: Debri removed from flap gate on waterside tow FIELD_STRUCT_DESC: 36-inch square reinforced concrete storm drain box culvert through the levee 21.0 feet below the crown. Concrete "U" shaped headwalls on both ends. Slide gate in 6'X7' concrete riser unit on the waterward slope. Flap gate on the waterward end. Flashboard slots on the landside headwall. Originally included in the 1968 O&M manual. FS Date: 3/2/2015

Flap gate and U shaped headwall on WS toe. Debris blocking closure of gate.

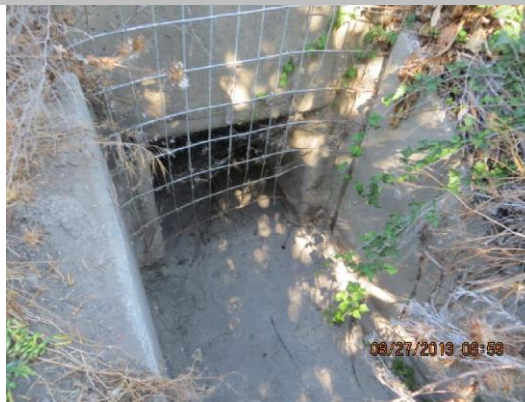
Photo 3 of 3 : UCIP_SP_2017_43603_31256.jpg

Concrete headwall at inlet on LS toe.

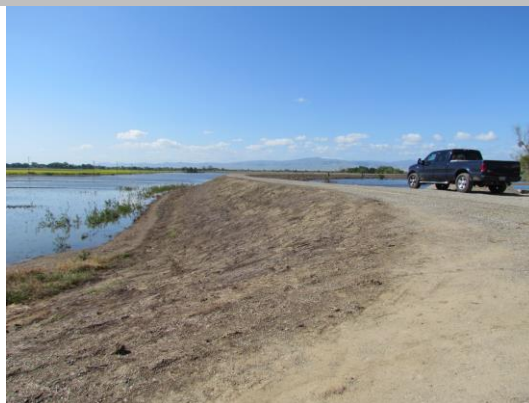
Photo 1 of 1 : SP_2017_RD2064_313_22_20170517_00044.jpg

LM Start	0.08	Rating **	A	Issue No.	22
LM End	5.53	Issue Type +	Ma	Location *	LS
Category	Earthen Levee			GPS Latitude/Longitude	
				Start	End
Item	Vegetation			37.709490 °	37.667562 °
				-121.267525 °	-121.241075 °
DWR ID	DWR_RD2064_01_s_2017_22				
Comment Code					
V1 : Control annual grass and weeds on the levee slopes and easements.					
Inspector Comment					
There is no unwanted vegetation levee mile 0.08-5.53.

Looking upstream from levee mile 0.08 landside slope.

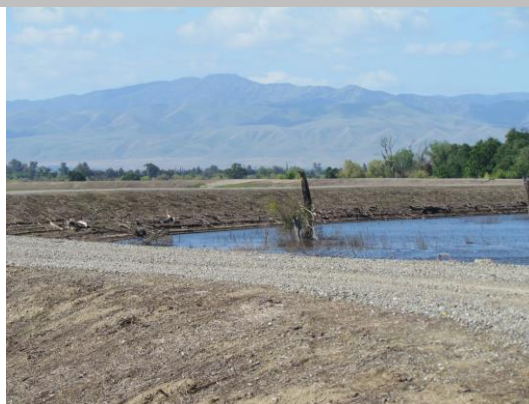
Photo 1 of 1 : SP_2017_RD2064_313_23_20170424_00043.jpg

LM Start	0.08	Rating **	A	Issue No.	23
LM End	5.53	Issue Type +	Ma	Location *	WS
Category	Earthen Levee			GPS Latitude/Longitude	
				Start	End
Item	Vegetation			37.709490 °	37.667562 °
				-121.267525 °	-121.241075 °
DWR ID	DWR_RD2064_01_s_2017_23				
Comment Code					
V1 : Control annual grass and weeds on the levee slopes and easements.					
Inspector Comment					
No unwanted vegetation on the water slope from levee mile 0.08-5.53.

Standing at levee mile 0.08 looking upstream.

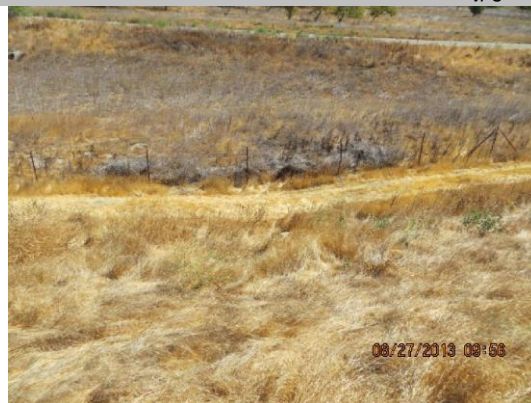
Photo 1 of 3 : UCIP_SP_2017_18748_31380.jpg

LM Start	1.65	Rating **	A/W	Issue No.	34
LM End	1.65	Issue Type +	Ma	Location *	WS
Category	Supplemental			GPS Latitude/Longitude	
				Start	End
Item	DWR UCIP LMA Responsibility			37.690072 °	37.690072 °
				-121.269823 °	-121.269823 °
DWR ID					
Comment Code					
Inspector Comment					
FS_ID:18748					
DS_ID:20514					
EP_NO: N/A					
Repair Type: No Action Needed					
Crossing Status: Found					
UCIP Comments:					
FIELD_STRUCT_DESC: 30-inch square reinforced concrete box culvert					
through the levee 15.0-feet below the crown. Slide gate in concrete riser					
unit on the waterward shoulder. Concrete "U" headwalls on both ends.					
Flap gate on the waterward end. Originally included in the 1968 O&M					
manual.					
FS Date: 8/27/2013

Concrete headwall on LS toe.

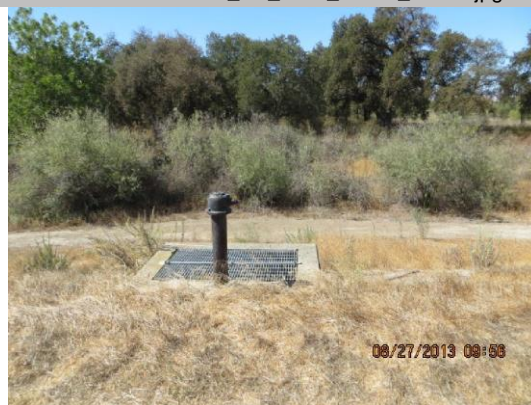
Photo 2 of 3 : UCIP_SP_2017_18748_31379.jpg

Slide gate in concrete vault on WS shoulder.

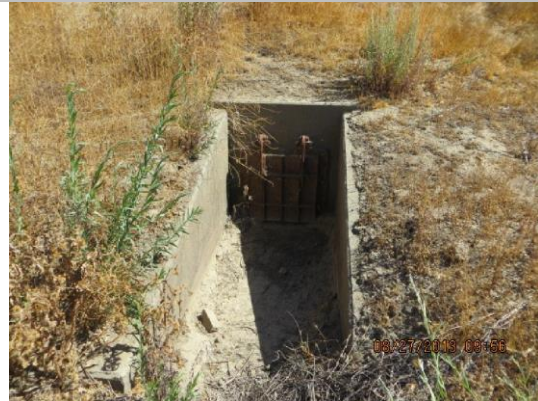
Photo 3 of 3 : UCIP_SP_2017_18748_31378.jpg

Flap gate on WS toe.

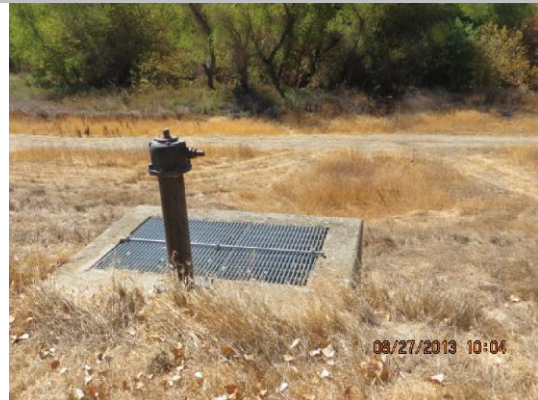
Photo 1 of 3 : UCIP_SP_2017_18763_31402.jpg

LM Start	1.94	Rating **	M	Issue No.	35
LM End	1.94	Issue Type +	Ma	Location *	WS
Category	Supplemental			GPS Latitude/Longitude	
				Start	End
Item	DWR UCIP LMA Responsibility			37.689900 °	37.689900 °
				-121.264802 °	-121.264802 °
DWR ID					
Comment Code					
Inspector Comment					
FS_ID:18763					
DS_ID:20515					
EP_NO: N/A					
Repair Type: Non-Urgent					
Crossing Status: Found					
UCIP Comments: Culvert filled nearly to the top with soil.					
FIELD_STRUCT_DESC: 30-inch square reinforced concrete stormdrain box culvert through the levee 14.7-feet below the crown. Slide gate in concrete riser unit on the waterward slope. Concrete "U" shaped headwalls on both ends. Flap gate on the waterward end. Originally included in the 1968 O&M manual.					
FS Date: 8/27/2013

Slide gate in Concrete riser on WS shoulder.

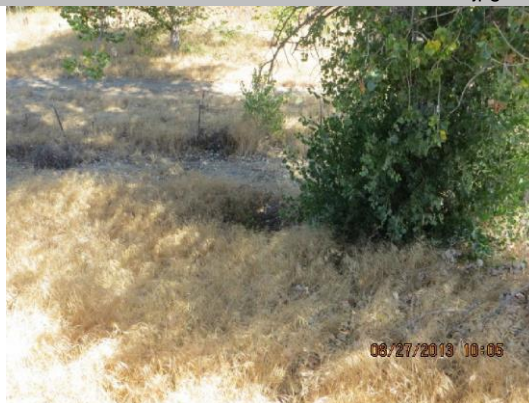
Photo 2 of 3 : UCIP_SP_2017_18763_31401.jpg

LM Start	1.94	Rating **	M	Issue No.	35 (cont)	
LM End	1.94	Issue Type +	Ma	Location *	WS	
Category	Supplemental			GPS Latitude/Longitude		
				Start	End	
Item	DWR UCIP LMA Responsibility			37.689900 °	37.689900 °	
				-121.264802 °	-121.264802 °	
DWR ID						
Comment Code						
Inspector Comment						
FS_ID:18763 DS_ID:20515 EP_NO: N/A Repair Type: Non-Urgent Crossing Status: Found UCIP Comments: Culvert filled nearly to the top with soil. FIELD_STRUCT_DESC: 30-inch square reinforced concrete stormdrain box culvert through the levee 14.7-feet below the crown. Slide gate in concrete riser unit on the waterward slope. Concrete "U" shaped headwalls on both ends. Flap gate on the waterward end. Originally included in the 1968 O&M manual. FS Date: 8/27/2013

Concrete U-shaped headwall on LS toe.

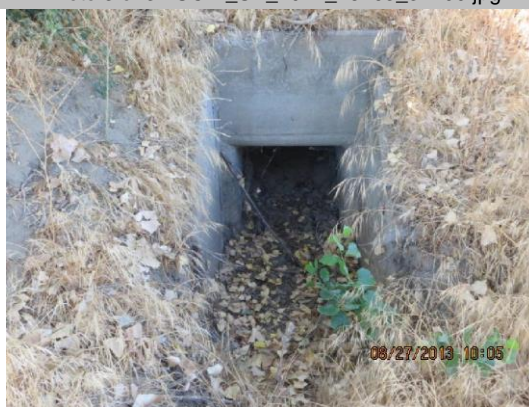
Photo 3 of 3 : UCIP_SP_2017_18763_31400.jpg

Concrete U-shaped headwall on LS toe.

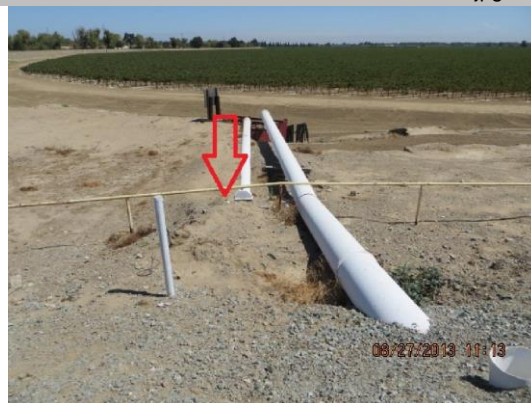
Photo 1 of 2 : UCIP_SP_2017_22732_38465.jpg

LM Start	3.57	Rating **	M	Issue No.	40
LM End	3.57	Issue Type +	Ma	Location *	WS
Category	Supplemental			GPS Latitude/Longitude	
				Start	End
Item	DWR UCIP LMA Responsibility			37.675266 °	37.675266 °
				-121.263421 °	-121.263421 °
DWR ID					
Comment Code					
Inspector Comment					
FS_ID:22732 DS_ID:20525 EP_NO: N/A Repair Type: Non-Urgent Crossing Status: Found UCIP Comments: Need to determine if pipe was actually removed from levee. FIELD_STRUCT_DESC: 12-inch steel stormdrain pipe through the levee at unknown depth below the crown. Steel plate welded over LS end at LS toe. Permit No. 6450, states it was removed in 1973, but it remains visible on the LS toe. Originally included in the 1968 O&M manual. FS Date: 8/27/2013

Pipe visible on LS toe.

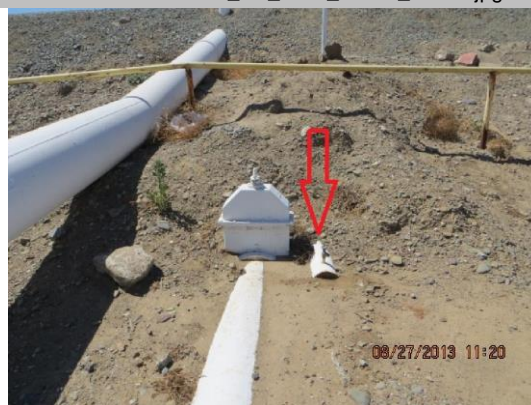
Photo 2 of 2 : UCIP_SP_2017_22732_38464.jpg

Pipe with welded steel plate over LS end at LS toe.

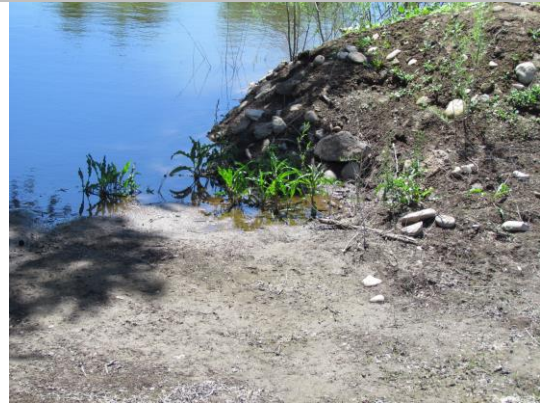
Photo 1 of 1 : SP_2017_RD2064_314_19_20170518_00049.jpg

LM Start	0.33	Rating **	U	Issue No.	19		
LM End	0.33	Issue Type +	Ma	Location *	WS		
Category	Earthen Levee			GPS Latitude/Longitude			
				Start	End		
Item	Erosion / Bank Caving				o		o
					o		o
DWR ID	DWR_RD2064_02_s_2017_19						
Comment Code							
E2 : Schedule repair of erosion site prior to the next inspection.							
Inspector Comment							
This levee berm was damaged by the farmer who leases the property at this location a pump was replaced and structure was removed from the channel. Mr. Mathew Of MOCO FARMS.

Waterside berm at levee mile 0.33.

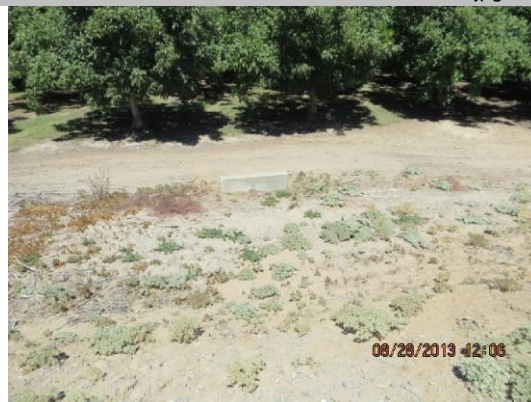
Photo 1 of 3 : UCIP_SP_2017_19117_32069.jpg

LM Start	4.41	Rating **	A/W	Issue No.	31
LM End	4.41	Issue Type +	Ma	Location *	LS
Category	Supplemental			GPS Latitude/Longitude	
				Start	End
Item	DWR UCIP LMA Responsibility			37.696386 °	37.696386 °
				-121.202963 °	-121.202963 °
DWR ID					
Comment Code					
Inspector Comment					
FS_ID:19117 DS_ID:20549 EP_NO: N/A Repair Type: No Action Needed Crossing Status: Found UCIP Comments: FIELD_STRUCT_DESC: 30-inch pipe through the levee 10.5-feet below the crown. Concrete "U" shaped headwalls on both ends. Flap gate on the waterward end. Two corrugated metal cutoff walls. Originally included in the 1968 O&M manual. FS Date: 8/28/2013

Headwall on LS toe.

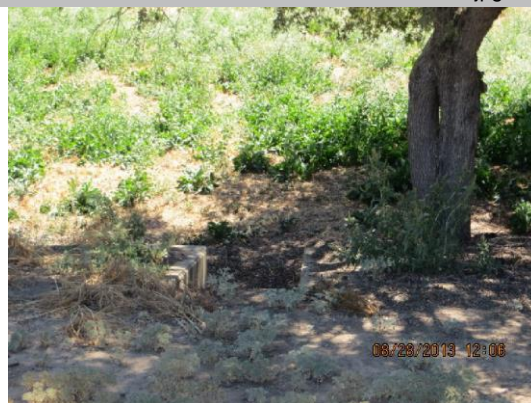
Photo 2 of 3 : UCIP_SP_2017_19117_32068.jpg

Headwall on WS toe.

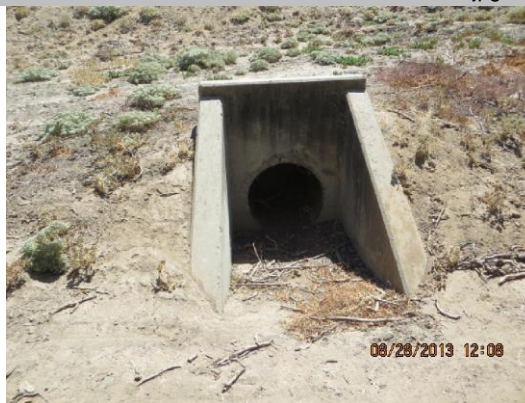
Photo 3 of 3 : UCIP_SP_2017_19117_32067.jpg

Headwall on LS toe.

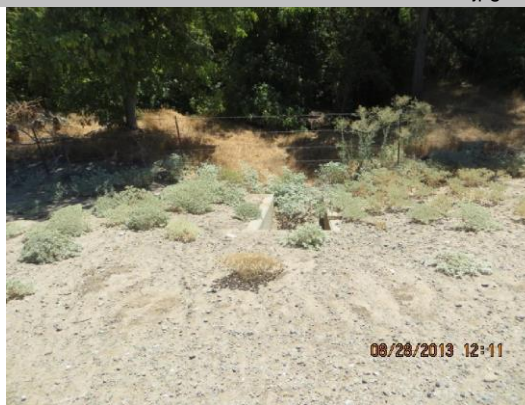
Photo 1 of 3 : UCIP_SP_2017_22793_38842.jpg

LM Start	4.51	Rating **	A/W	Issue No.	32
LM End	4.51	Issue Type +	Ma	Location *	LS
Category	Supplemental			GPS Latitude/Longitude	
				Start	End
Item	DWR UCIP LMA Responsibility			37.696892 °	37.696892 °
				-121.201228 °	-121.201228 °
DWR ID					
Comment Code					
Inspector Comment					
FS_ID:22793					
DS_ID:20550					
EP_NO: N/A					
Repair Type: No Action Needed					
Crossing Status: Found					
UCIP Comments:					
FIELD_STRUCT_DESC: 30-inch corrugated metal stormdrain pipe					
through the levee 8.0-feet below the crown. Concrete "U" shaped					
headwalls on both ends and flap gate on the waterward end. Grouted					
spill way on the waterward side. Originally included in the 1968 O&M					
manual.					
FS Date: 8/28/2013

Concrete headwall on WS toe.

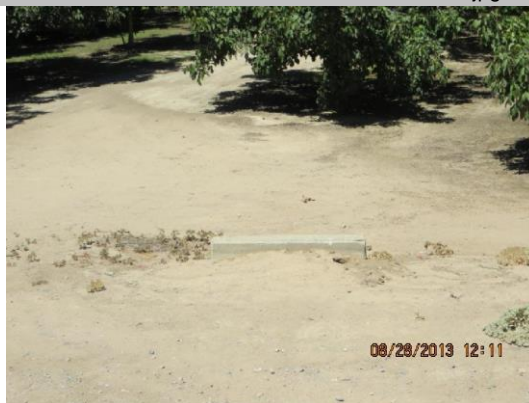
Photo 2 of 3 : UCIP_SP_2017_22793_38841.jpg

Concrete headwall on LS toe.

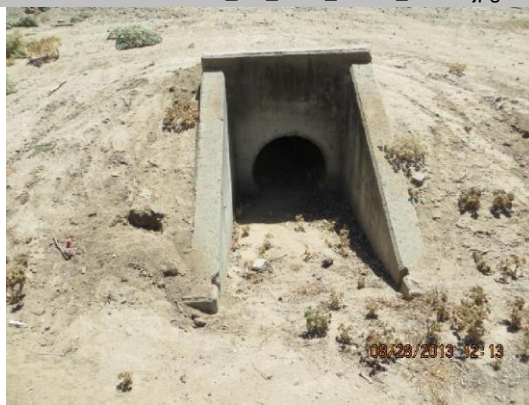
Photo 3 of 3 : UCIP_SP_2017_22793_38844.jpg

Concrete headwall on LS toe.

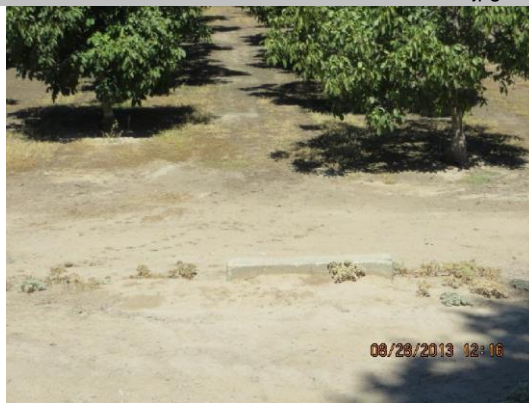
Photo 1 of 3 : UCIP_SP_2017_19120_32079.jpg

FS_ID:19120
DS_ID:20551
EP_NO: N/A
Repair Type: No Action Needed
Crossing Status: Found
UCIP Comments:
FIELD_STRUCT_DESC: 30-inch corrugated metal stormdrain pipe through the levee 10.0-feet below the crown. Concrete "U" shaped headwall on both ends. Flap gate on the waterward end. Two corrugated metal cutoff walls. Grouted spill way on the waterward side. Spill way damaged due to uprooted tree. Originally included in the 1968 O&M manual.
FS Date: 8/28/2013

Concrete headwall on LS toe.

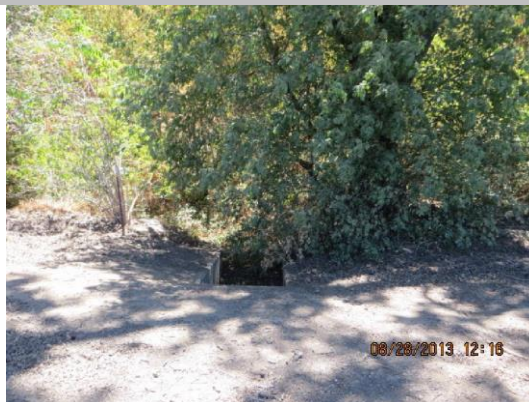
Photo 2 of 3 : UCIP_SP_2017_19120_32078.jpg

Concrete headwall on WS toe.

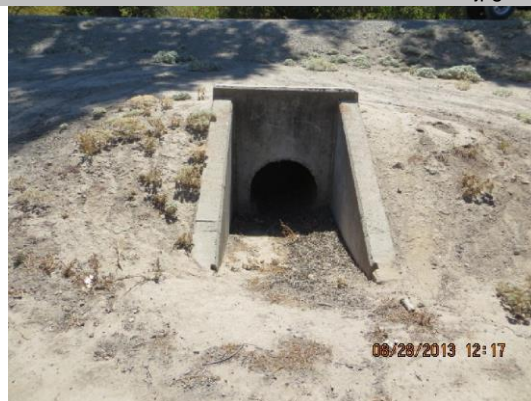
Photo 3 of 3 : UCIP_SP_2017_19120_32077.jpg

Concrete headwall on LS toe.

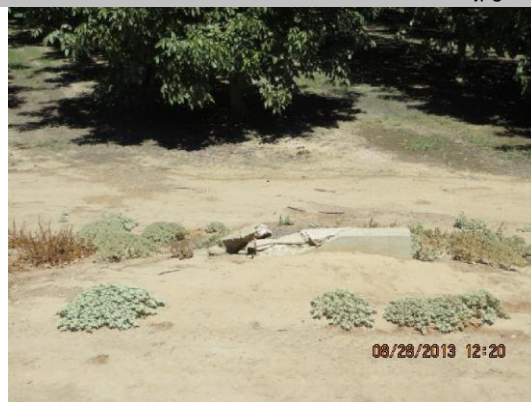
Photo 1 of 3 : UCIP_SP_2017_19122_32083.jpg

LM Start	4.78	Rating **	A/W	Issue No.	34
LM End	4.78	Issue Type +	Ma	Location *	LS
Category	Supplemental			GPS Latitude/Longitude	
				Start	End
Item	DWR UCIP LMA Responsibility			37.696888 °	37.696888 °
				-121.196511 °	-121.196511 °
DWR ID					
Comment Code					
Inspector Comment					
FS_ID:19122 DS_ID:20552 EP_NO: N/A Repair Type: No Action Needed Crossing Status: Found UCIP Comments: FIELD_STRUCT_DESC: 30-inch corrugated metal stormdrain pipe through the levee 8.5 feet below the crown. Concrete "U" shaped headwall on both ends. Flap gate on the waterward end. Two corrugated metal cutoff walls and grouted spillway on the waterward side. Originally included in the 1968 O&M manual. FS Date: 8/28/2013

Concrete headwall on LS toe.

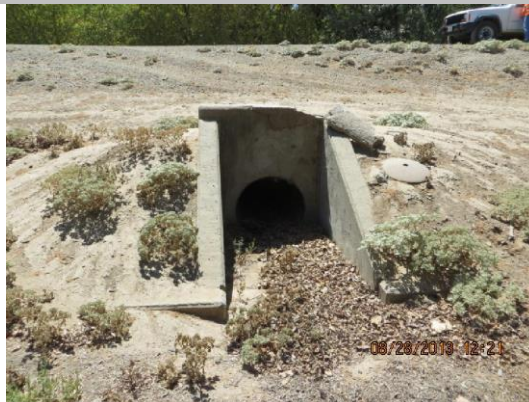
Photo 3 of 3 : UCIP_SP_2017_19122_32081.jpg

Concrete headwall on LS toe.

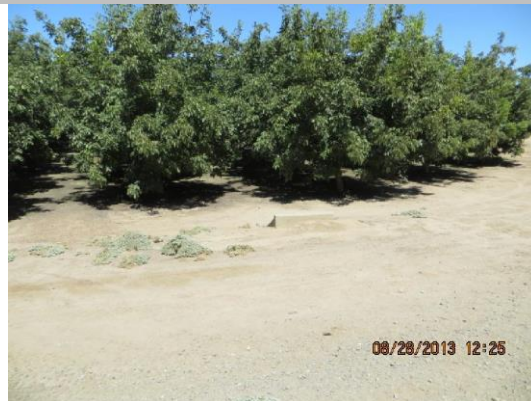
Photo 1 of 3 : UCIP_SP_2017_19143_32122.jpg

LM Start	4.92	Rating **	A/W	Issue No.	37
LM End	4.92	Issue Type +	Ma	Location *	LS
Category	Supplemental			GPS Latitude/Longitude	
				Start	End
Item	DWR UCIP LMA Responsibility			37.696146 °	37.696146 °
				-121.194093 °	-121.194093 °
DWR ID					
Comment Code					
Inspector Comment					
FS_ID:19143					
DS_ID:20553					
EP_NO: N/A					
Repair Type: No Action Needed					
Crossing Status: Found					
UCIP Comments:					
FIELD_STRUCT_DESC: 30-inch CMP stormdrain pipe through the					
levee 8.0 feet below the crown. Concrete "U" headwall on both ends.					
Flap gate on the waterward end. Two corrugated metal cutoff walls.					
Grouted spillway on the waterward side. Originally included in the 1968					
O&M manual.					
FS Date: 8/28/2013

Concrete headwall on LS toe.

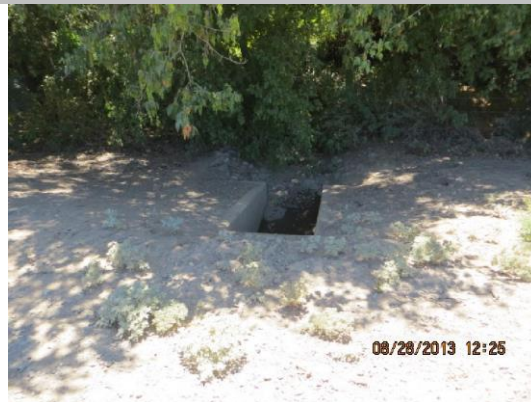
Photo 2 of 3 : UCIP_SP_2017_19143_32121.jpg

Concrete headwall on WS toe.

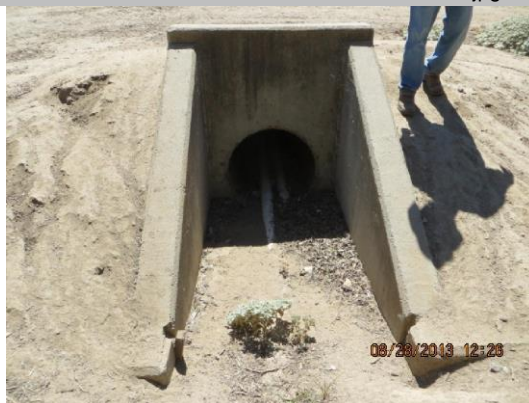
Photo 3 of 3 : UCIP_SP_2017_19143_32120.jpg

Concrete headwall on LS toe.

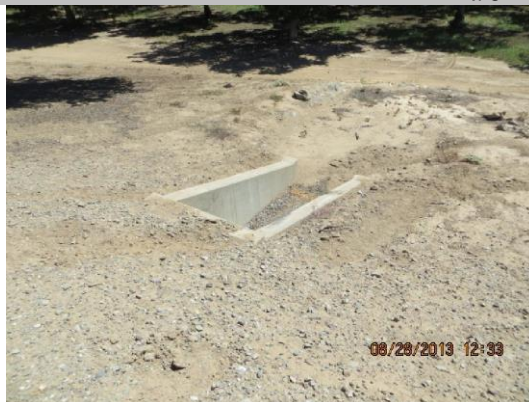
Photo 1 of 3 : UCIP_SP_2017_22794_38851.jpg

LM Start	5.10	Rating **	A/W	Issue No.	38
LM End	5.10	Issue Type +	Ma	Location *	LS
Category	Supplemental			GPS Latitude/Longitude	
				Start	End
Item	DWR UCIP LMA Responsibility			37.697483 °	37.697483 °
				-121.191332 °	-121.191332 °
DWR ID					
Comment Code					
Inspector Comment					
FS_ID:22794 DS_ID:20554 EP_NO: N/A Repair Type: No Action Needed Crossing Status: Found UCIP Comments: FIELD_STRUCT_DESC: 30-inch corrugated metal stormdrain pipe through the levee 8.0-feet below the crown. Concrete "U" headwall on both ends. Flap gate on the waterward end. Two corrugated metal cutoff walls. Grouted spillway on the waterward side. Originally included in the 1968 O&M manual. FS Date: 8/28/2013

Concrete U shaped headwall on WS toe.

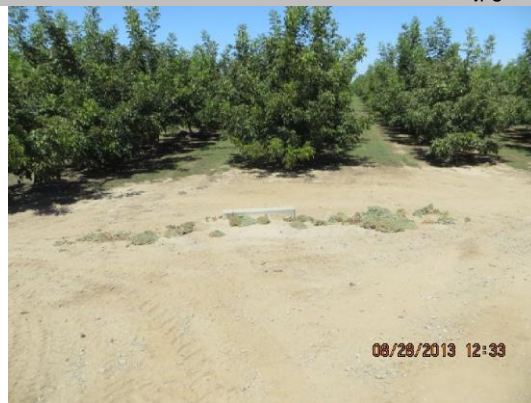
Photo 2 of 3 : UCIP_SP_2017_22794_38850.jpg

LM Start	5.10	Rating **	A/W	Issue No.	38 (cont)
LM End	5.10	Issue Type +	Ma	Location *	LS
Category	Supplemental			GPS Latitude/Longitude	
				Start	End
Item	DWR UCIP LMA Responsibility			37.697483 °	37.697483 °
				-121.191332 °	-121.191332 °
DWR ID					
Comment Code					
Inspector Comment					
FS_ID:22794					
DS_ID:20554					
EP_NO: N/A					
Repair Type: No Action Needed					
Crossing Status: Found					
UCIP Comments:					
FIELD_STRUCT_DESC: 30-inch corrugated metal stormdrain pipe through the levee 8.0-feet below the crown. Concrete "U" headwall on both ends. Flap gate on the waterward end. Two corrugated metal cutoff walls. Grouted spillway on the waterward side. Originally included in the 1968 O&M manual.					
FS Date: 8/28/2013

Concrete headwall on LS toe.

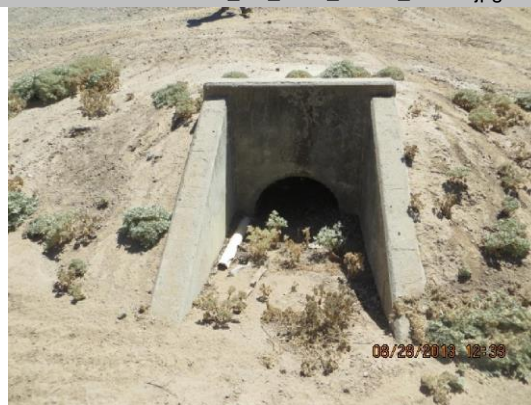
Photo 3 of 3 : UCIP_SP_2017_22794_38853.jpg

Concrete headwall on LS toe.
